AEROPRAKT

SAFETY ALERT

No. SAA-22-01

Model: A22LS

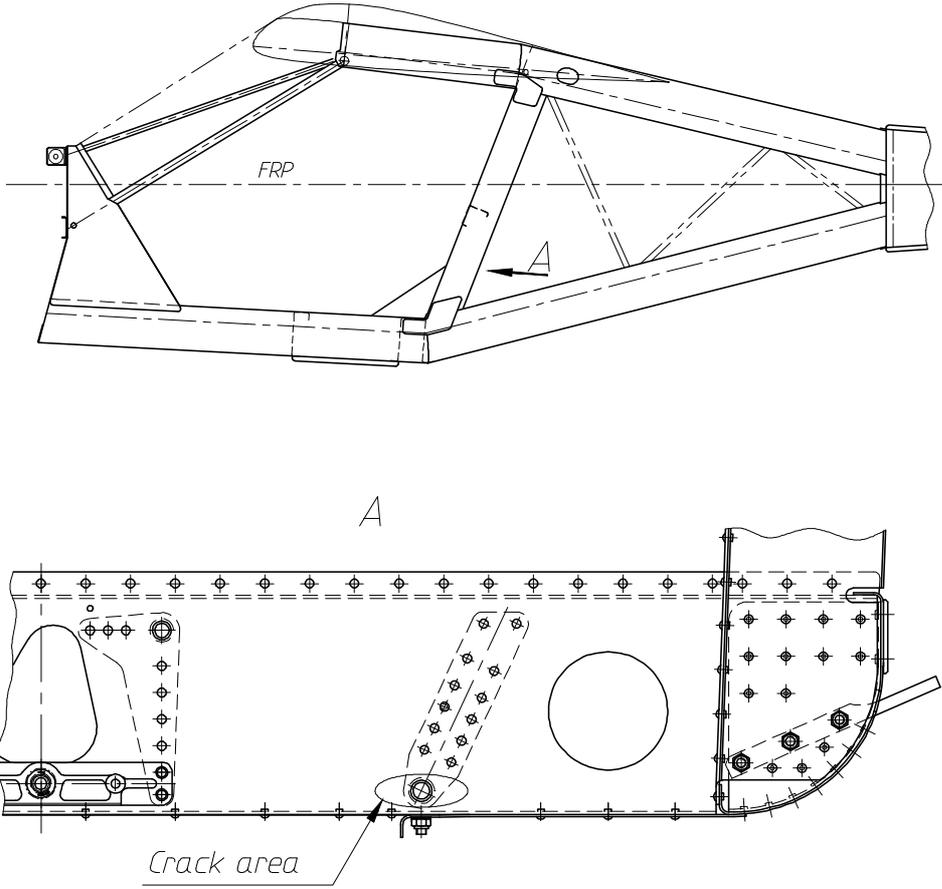
Fig. 1

It was found out that an energetic braking on a hard surface runway causes resonance vibration of the main landing gear legs. The vibrations in their turn cause elastic oscillations of the bottom fuselage skin in the area of the outer lower attachment fitting of the main landing gear leg, which may result in fatigue cracks in the rear web of the transverse beam of the main landing gear attachment. To reduce the probability of crack creation it is necessary to increase the stiffness of fuselage skin in the area of the attachment fittings of the main landing gear using the reinforcing angles. **It is strongly recommended to avoid the resonance vibrations of the main landing gear.**

1. Inspect the beam for cracks in the specified (see fig. 1).
If cracks are found it is necessary to perform the repair work according to p. 3.1.2, otherwise carry out inspection regularly.

◆ **NOTE:** The beam must be inspected on the sides of both left and right landing gear leg, regardless the fact that the figure below shows only the right leg.

1. If cracks are found in the beam (see fig. 1) it is necessary to drill the crack ends with $\varnothing 3.1$ mm drill bit, remove the burrs and coat with primer.
2. Remove the bolts (13) of fitting (2) attachment to fuselage (see fig. 2).
3. Drill out the rivets (11, 12) with $\varnothing 3.1$ mm drill bit (see fig. 2).
4. Apply the reinforcing angle to fuselage (1), drill it to the fuselage and fix with Clico fasteners.
5. Drill the bolt holes (13) with $\varnothing 6.2$ mm drill bit in fuselage and ream them with $\varnothing 1/4H7$ reamer.
6. Remove the Clico fasteners and angle and clean it from metal chips.
7. Fix the angle (1) with Clico fasteners.
8. Install the bolts (13) with primer.
9. Install the rivets (11, 12).
