# AEROPRAKT NOTIFICATION

No. N A22LS-25

## HOLES IN THE FLAPERON HINGE AXLES IN A22LS AND A22L2 AIRCRAFT

Model: A22LS and A22L2

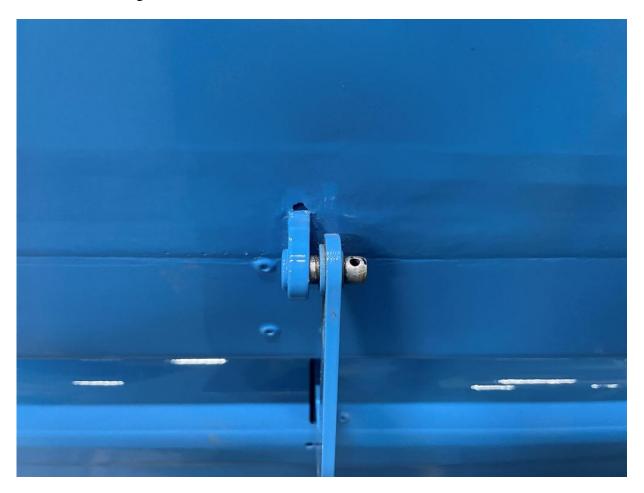
◆ These holes are not intended for any safety pins or wire in the flaperon hinge axles. They are present because the flaperon hinge axles are made of a standard part (a pin with a hole for the safety pin/wire) the hole in which may be necessary for locking or safety pin/wire in other aircraft components. These holes in the flaperon hinge axles do not affect in any way or degree the normal function of the hinges.

■ Do not put any safety pins or wire in the holes in the flaperon hinge axles (see the photo below). It is a type-certified design. Failure to follow this instruction will invalidate compliance of your aircraft to the type design and type certificate.
