AEROPRAKT INFORMATION BULLETIN

INSPECTION OF CARDAN RINGS AND AMMENDMENT TO AIRCRAFT MAINTENANCE MANUALS OF A-22LS AND A-22L2 AIRPLANES.

IB A-22LS-10

MANDATORY

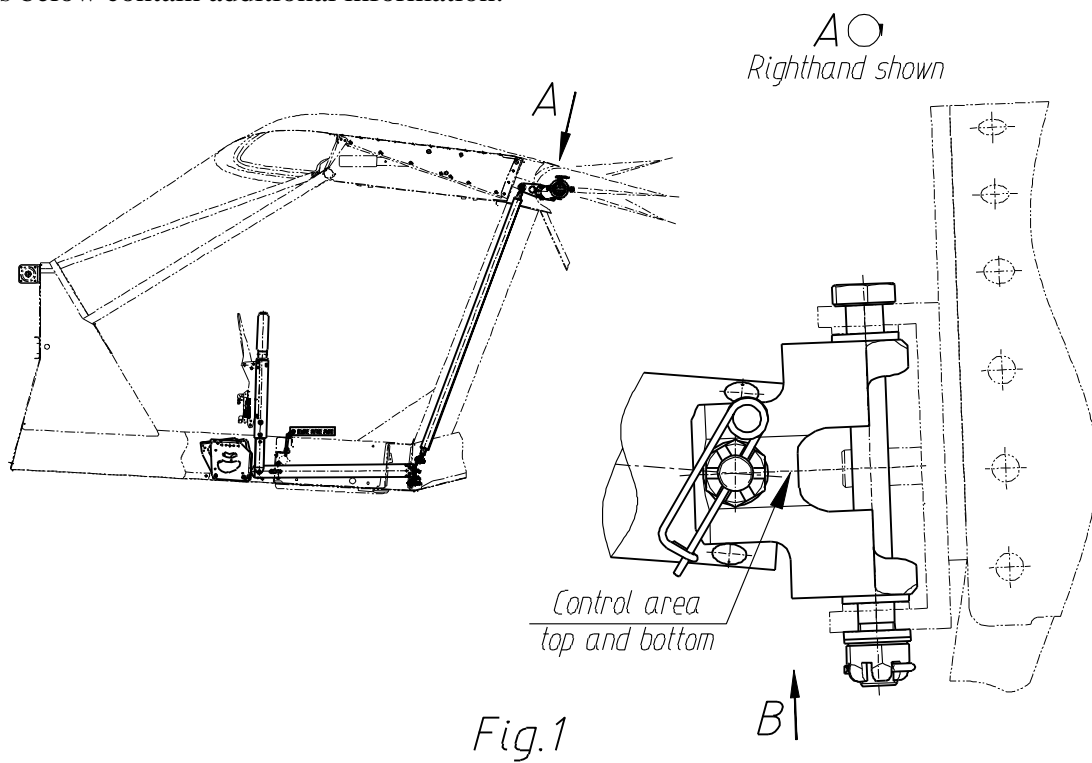
It was found out that an excessive tightening of the nut on the bolt joining the cardan ring to the flaperon shaft results in a significant deformation of the cardan ring and of the flaperon shaft end which causes cracks in the cardan ring. To avoid this excessive deformation of the joint the nut must be tightened with a torque of 2 Nm.

1. Inspect the cardan rings of the right and left flaperon for cracks (see fig. 1). Replace the cardan ring if any crack is detected.
2. If “S” dimension exceeds 55.0 mm check the nut tightening using torque wrench. If there is a gap between the flaperon shaft and cardan ring then the flaperon shaft deformation must be removed.
3. If “S” dimension is less than 55.0 mm then the flaperon shaft deformation must be removed and the cardan ring must be replaced.

◆ **NOTE:** Inspection and measurement of the cardan rings must be done on both right and left sides, although fig. 1 shows only the right side.
