AEROPRAKT INFORMATION BULLETIN INSPECTION AND REINFORCEMENT OF THE MAIN LANDING GEAR BEAM OF A-22 AIRCRAFT IB A-22-04

MANDATORY

All versions of Aeroprakt-22 aircraft from №1 to №130

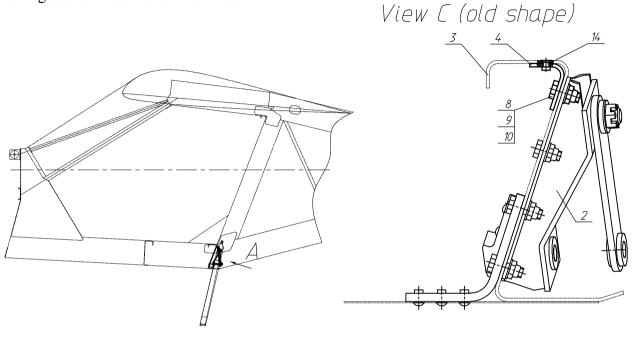
Fig. 1

It has been found out, that the cracks in the landing gear beam and brackets (fig. 1) appear due to fatigue damage in the result of intensive aircraft operation on airfields with rough surface.

Remove the lending gear legs (1), right and left brackets (2, see fig.1). Inspect the landing gear beam (3) and brackets for absence of cracks in the specified area. If any cracks are detected on the beam, perform the retrofit work according to section 3.1.1 (fig.2a, 2b). In case if cracks are detected on the brackets, perform retrofit work according to section 3.1.2 (fig.3).
