AEROPRAKT INFORMATION BULLETIN

REPLACEMENT OF THE NOSE LANDING GEAR LEG SPRING OF A-22 AIRCRAFT IB A-22-06

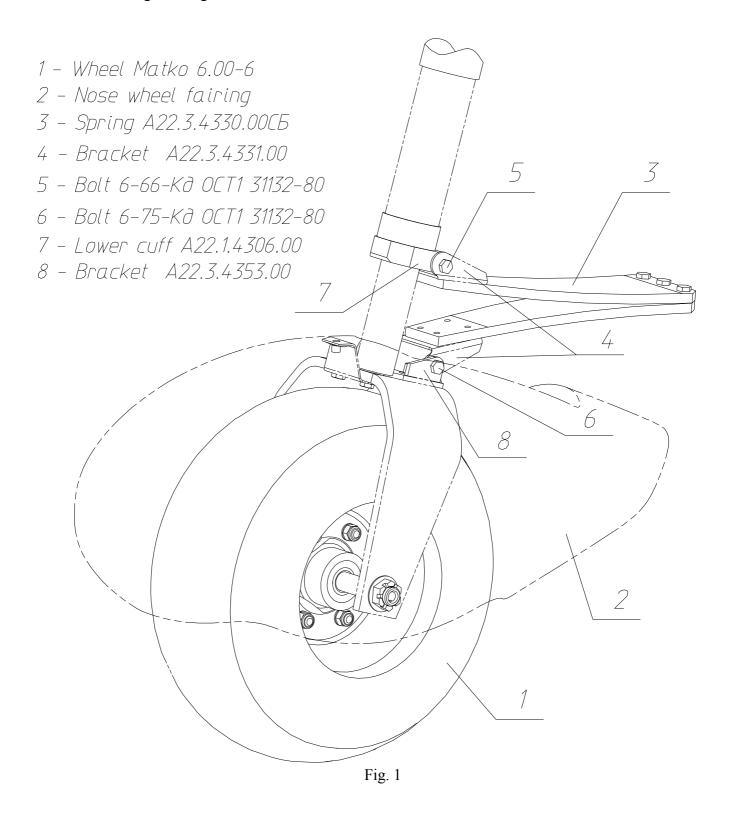
The cracks appear in the nose landing gear spring due to fatigue damage.

- 1) remove the wheel (item 1);
- 2) remove the fairing (item 2);
- 3) compress the spring (item 3) in area of brackets (4) using clamps.
- 4) take out the upper (item 5) and lower (item 6) bolts, remove the spring;
- 5) take the new spring, compress it and install in place of the old one;
- 6) put back the upper and lower bolts and cotter it;
- 7) put the fairing and wheel.
- ◆ NOTE: if the fearing is not installed, it is not necessarily to remove the wheel.
- ◆ NOTE: Lubricate the contacting surface of the brackets (item 4), lower cuff (item 7) and bracket (item 8) before re-installing it.
- **WARNING:** if the spring is not replaced in time (1.4), the nose landing gear leg may fail, this will cause the airplane nose-over.
