## **Aeroprakt Ltd**

# AEROPRAKT SERVICE BULLETIN

No. SB A32-02

# MODIFICATION OF ALL-MOVING HORIZONTAL TAIL (AMHT) OF A32 AND A32L AIRCRAFT

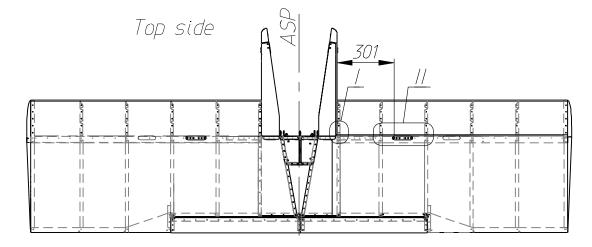
Bottom side 569

Inspect the AMHT in the area of mod kit parts installation (see detail views II and IV in fig. 1 and 2) for dents, deformation and cracks. If any damage is found in the above mentioned areas consult the manufacturer.

- Fig. 2
- 1. Installation of the top (righthand and lefthand) doublers:
- 1.1. Mark 2 holes (1 per righthand/lefthand side) on the top side of the AMHT at 301 mm distance as shown in fig. 1 and 3.
- 1.2. Drill the 2 marked holes with  $\emptyset$ 3.3 mm drill bit.
- 1.3. Install the doublers (1) on Cleco fasteners symmetrically about the aircraft symmetry plane (ASP).
- 1.4. Using the holes in the doublers as pilot holes drill  $\emptyset$ 3.3 mm holes 5 holes on each (righthand/lefthand) side.
- 1.5. Remove the doublers, deburr/blunt the sharp edges of the holes, remove the metal chips.
- 1.6. Attach the doublers with pop-rivets (3) and (4) as shown in fig. 3 (symmetrically about the ASP).
