AEROPRAKT SERVICE BULLETIN

No. SB A32-04

REINFORCEMENT OF THE ROOF PANEL RIVET JOINT AT FRAME No.3 OF A32 AND A32L AIRCRAFT

Model: A32, A32L

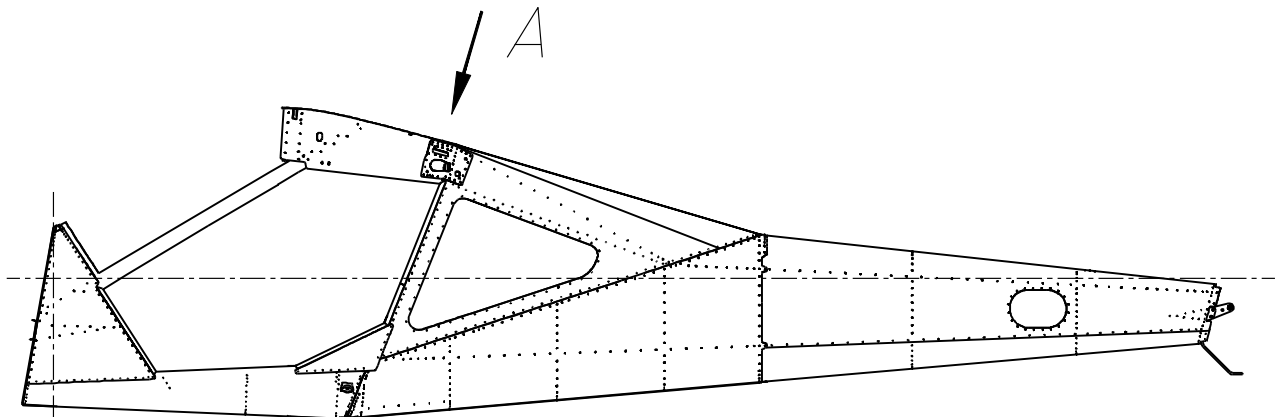
Fig.1

The rivets attaching the roof panel to the frame No.3 may become loose due to fatigue.

- 3.1) Inspect the rivet joint of the roof panel and frame No.3 (Fig.1, 2, 3), check number of the rivets (intervals between them) and their condition.
- 3.2) If number of the rivets (intervals between them) are as shown in Fig.3 and the rivets are not loosened, this repair work is not needed.
- 3.3) If number of the rivets (intervals between them) are as shown in Fig.2 and the rivets are loosened, this repair work must be accomplished.
 - 3.3.1) Mark and drill with $\varnothing 3.1$ mm drill bit the holes for additional rivets according to Fig.3.
 - 3.3.2) Insert and set the additional $\varnothing 3 \times 8$ rivets.
 - 3.3.3) Undrill the loosened rivets with $\varnothing 3.1$ mm drill bit and install the new $\varnothing 3 \times 8$ rivets.
 - 3.3.4) Paint the rivet heads with color of the airplane.
