AEROPRAKT SERVICE BULLETIN

No. SB A32-14

INSTALLATION OF HEAT SCREENS OF THE REAR ENGINE RUBBER MOUNTS OF A32 AND A32L AIRPLANES

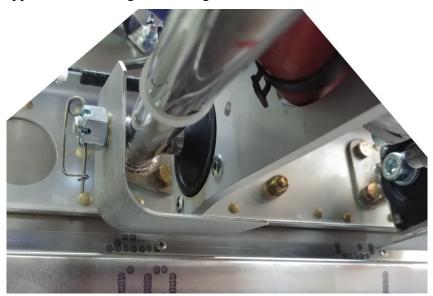
Intensive wear of the rear rubber shock absorbers of the engine mount due to the heat from the exhaust system elements.

- 3) Accomplishment / Instructions
- ▲ Failure to accomplish this work may cause complete disintegration of the rear rubber shock absorbers of the engine mount in flight.
- 3.1) Remove the upper and lower engine cowlings.
- 3.2) Remove the exhaust system without removing the exhaust gas temperature sensors from the exhaust pipes (if any).
- 3.3) Inspect the rear rubber shock absorbers for cracks and replace if necessary. Contact your local dealer on all issues regarding this replacement.
- 3.4) Install the heat screens on the left and right side as shown in Photo 1 for the right side and Photo 2 for the left side. The tightening torque of the M10 nuts is 20-25 Nm.
- 3.5) Re-install the exhaust system. The tightening torque of the M8 nuts is 15 Nm.
- 3.6) Re-install the upper and lower engine cowlings.
