# **AEROPRAKT SERVICE BULLETIN**

## **No. SB A22LS-17**

### **REPLACEMENT OF RUDDER CONTROL SYSTEM CABLES AND FAIRLEADS OF A-22, A-22L, A-22L2 AND A-22LS AIRCRAFT**

**Model: A-22, A-22L, A-22L2 and A-22LS**

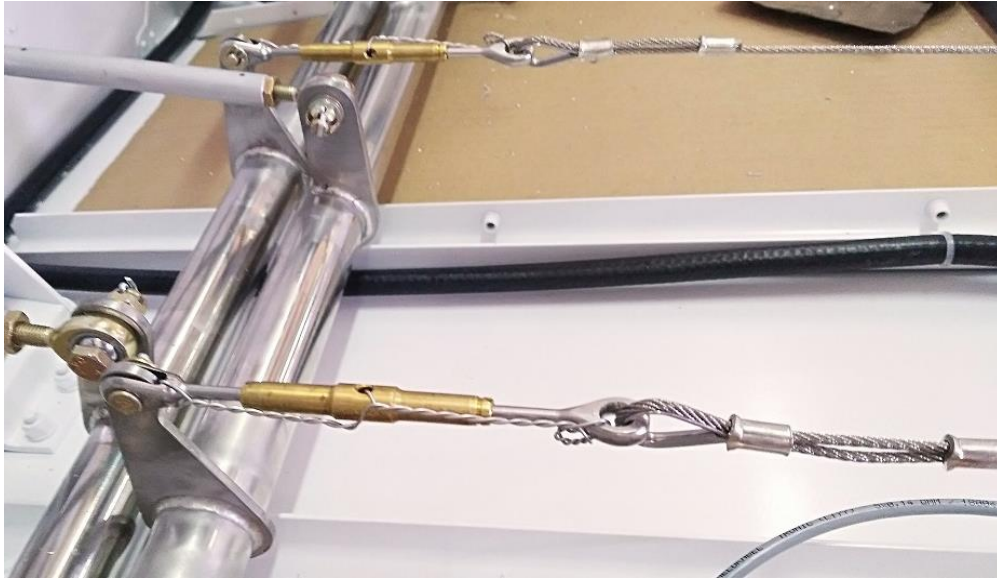
**Fig. 1.**

3.2) Remove safety wire from the turnbuckles and disconnect the cables from the levers of the pedal shafts (Fig.1).

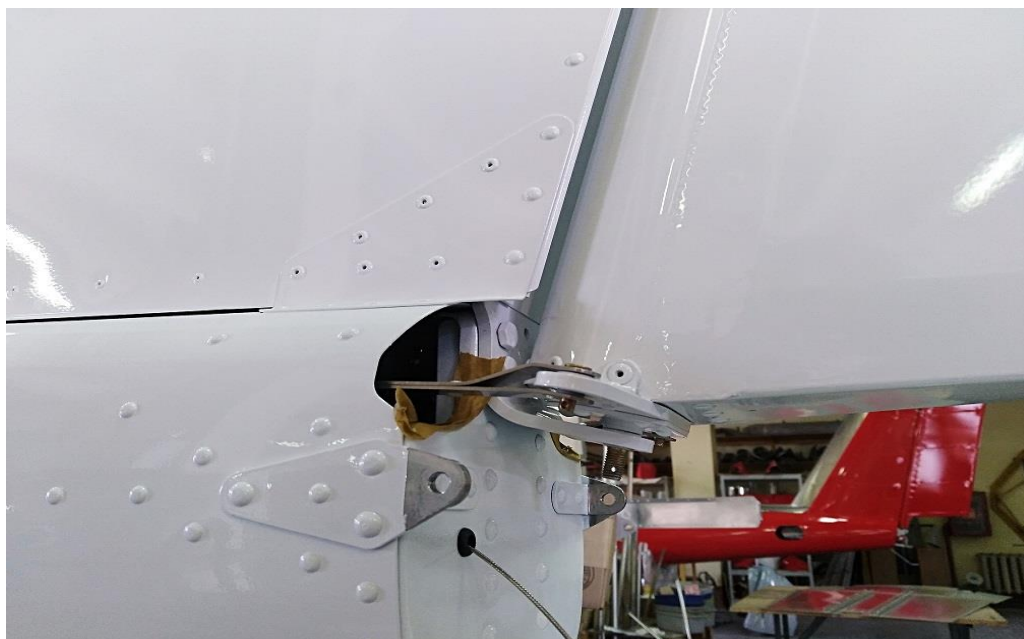
**Fig. 2.**

3.3) Remove the split pins from the pins attaching the cables to the rudder control arms (Fig.2). Hold the cable shackles and remove the pins. Tie the cable shackles with a cord approximately 3 meters long. Remove the rudder.

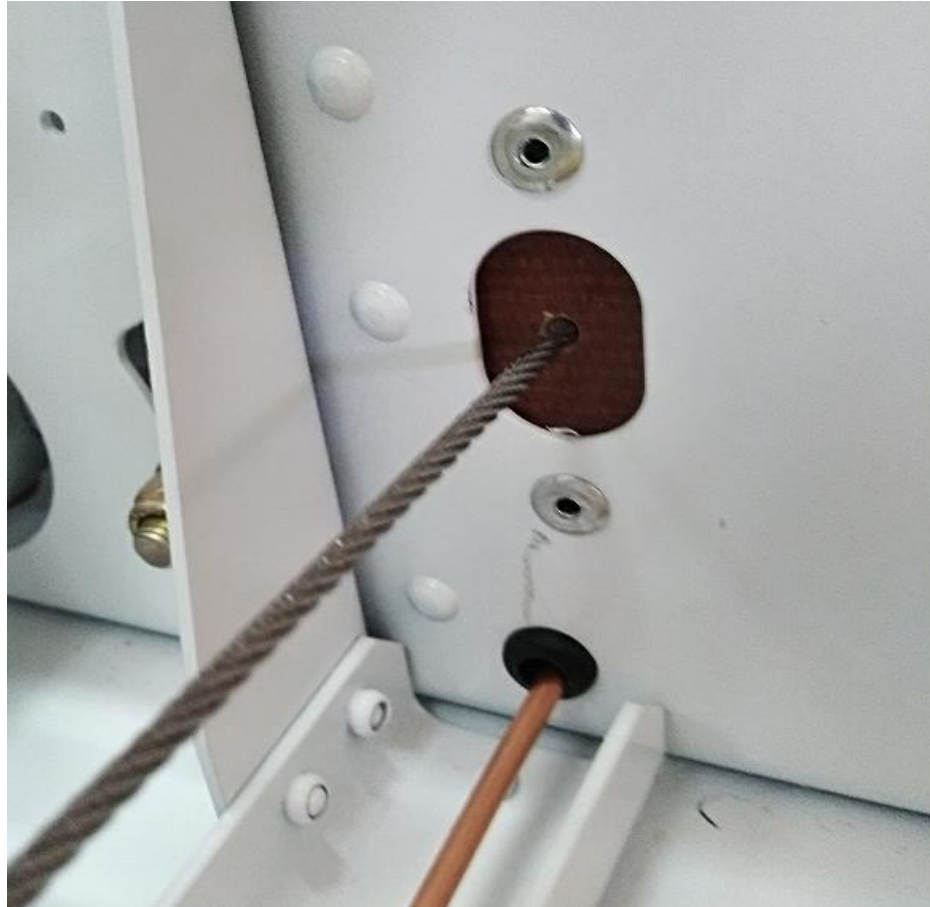
**Fig. 3.**

3.4) Remove the seats, drill out the rivets attaching the fairleads to the seat beam (Fig. 3).

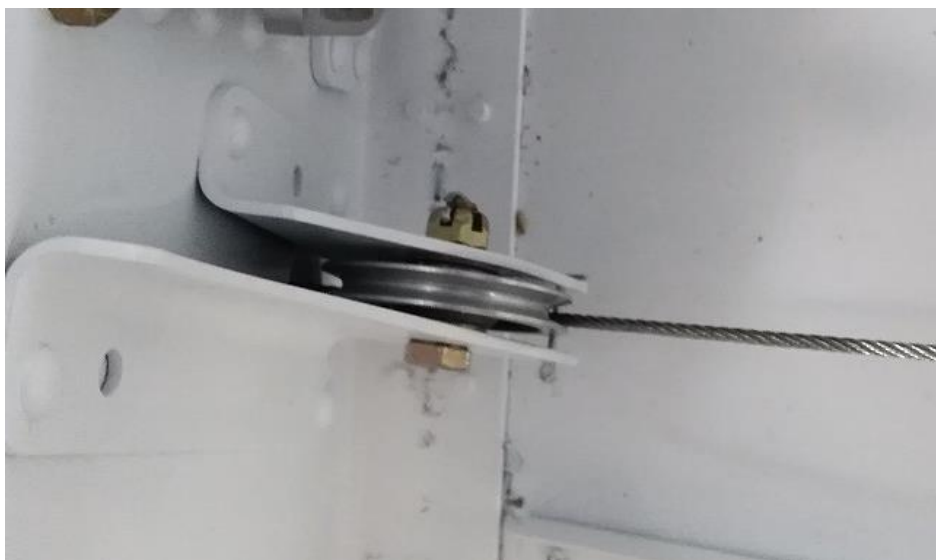
**Fig. 4.**

3.5) Remove the forward pulleys, located on the rear landing gear beam (Fig. 4).

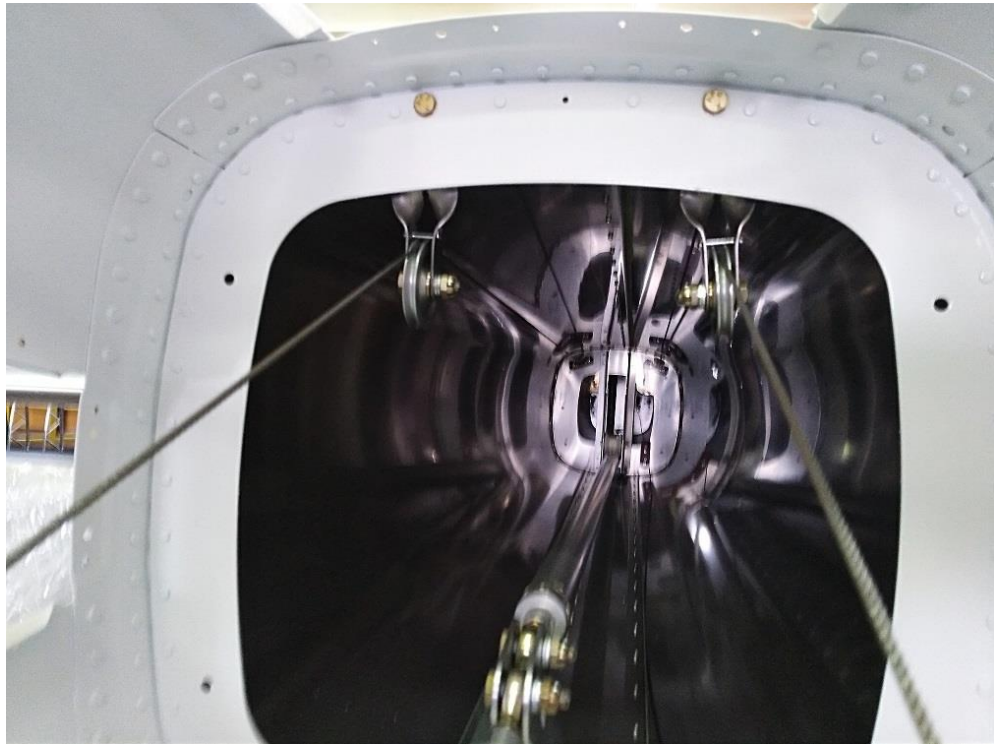
**Fig. 5.**

- 3.6) Remove the rear pulleys from their attachment brackets, put a support under the tail wheel to avoid aircraft tipping over on its tail (Fig. 5).

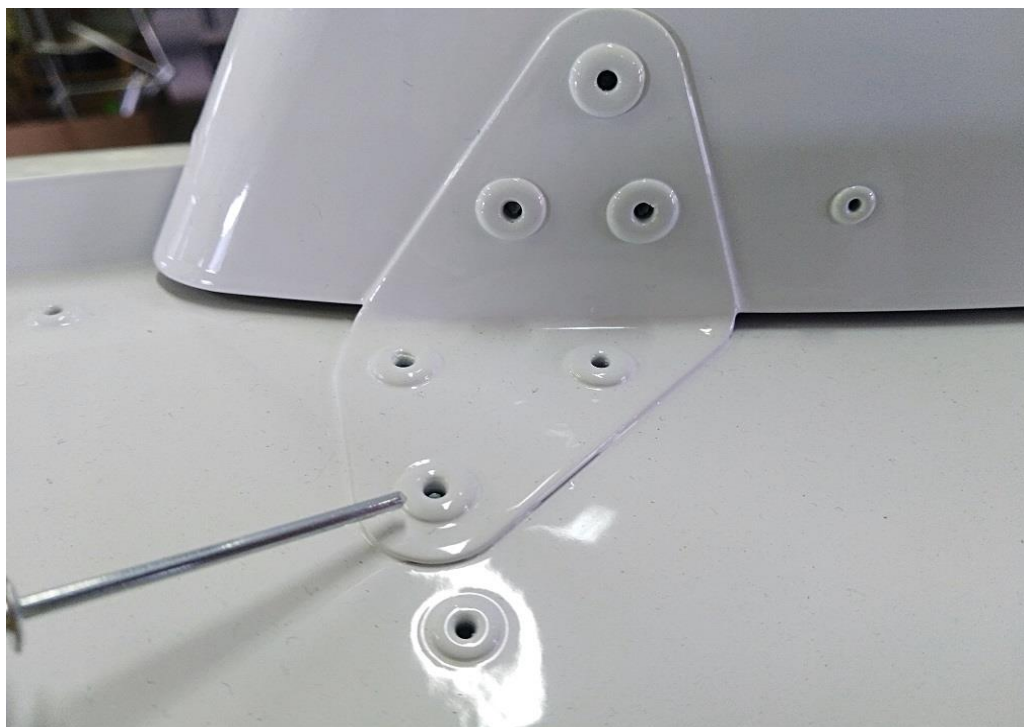
**Fig. 6.**

- 3.7) Drill out 3 rivets (shown on Fig.6) on the left side and 3 rivets on the right side of the front fin attachment fitting.

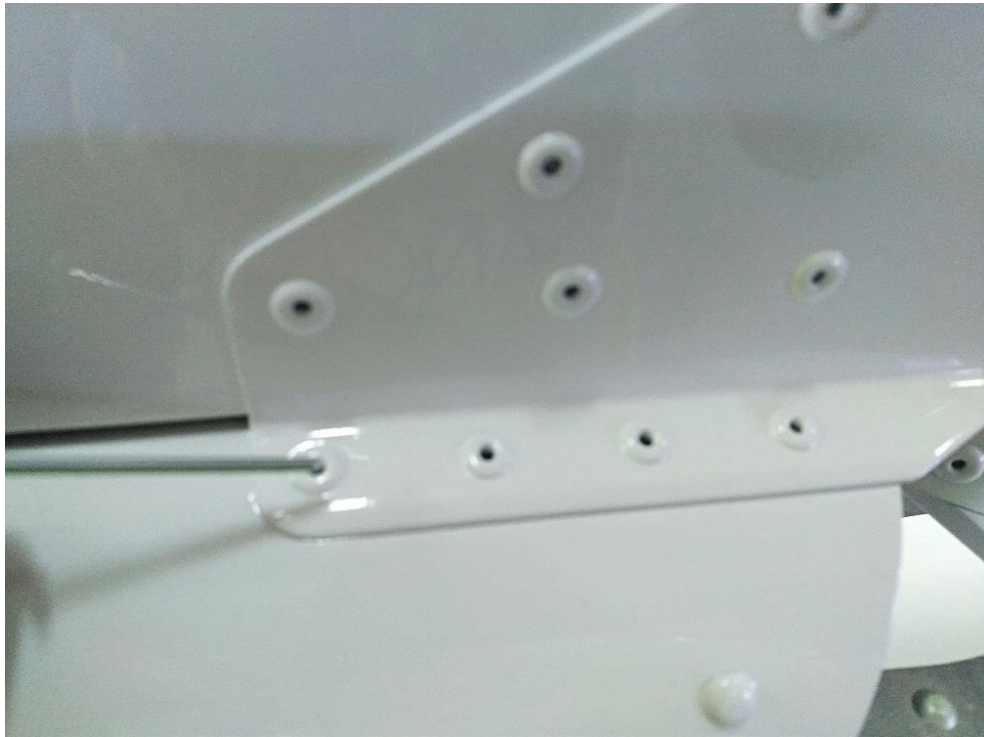
**Fig. 7.**

- 3.8) Drill out 4 rivets on the left side and 4 rivets on the right side of the rear fin attachment fitting (Fig.7).

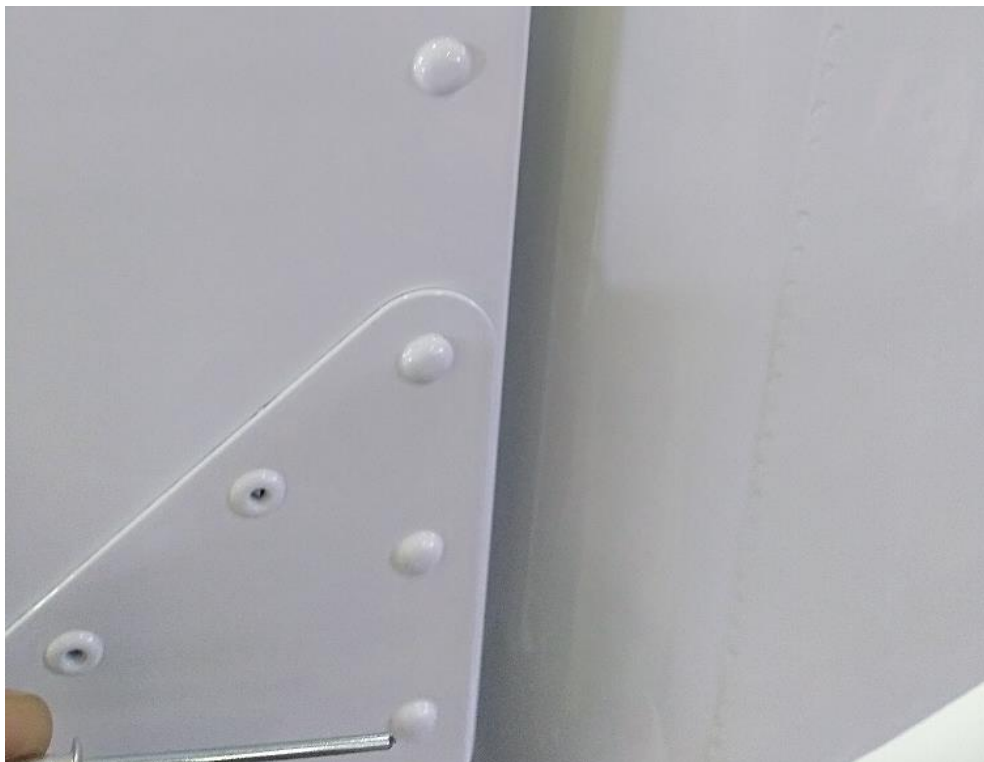
**Fig. 8.**

- 3.9) Drill out all rivets attaching the fin skin to the fin spar (Fig. 8).

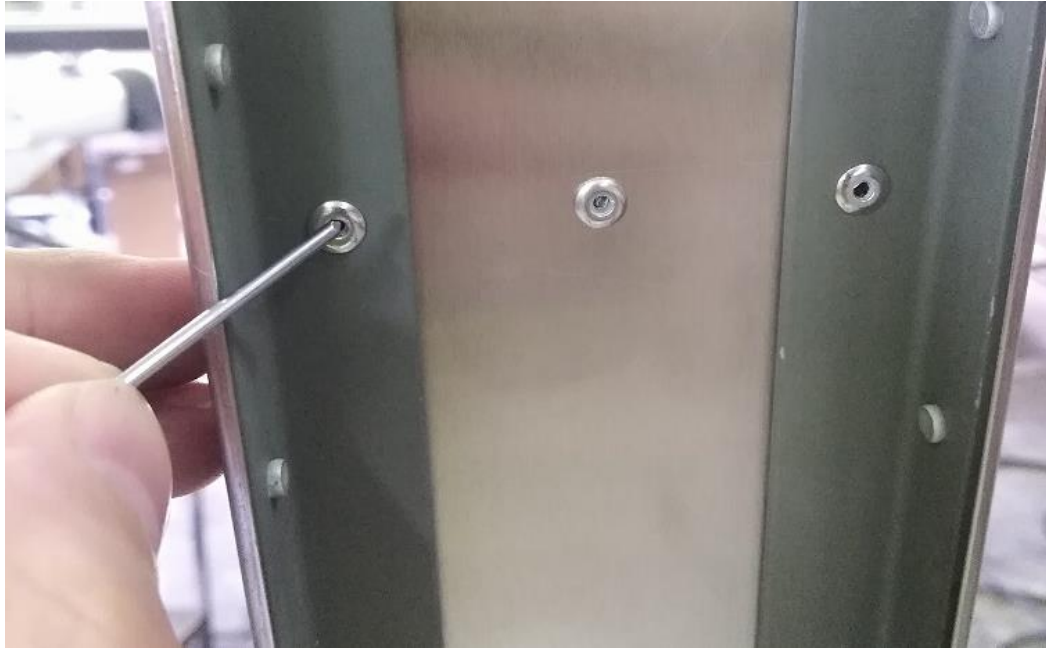
**Fig. 9.**

3.10) Drill out all rivets attaching the fin ribs to the fin spar (Fig. 9).

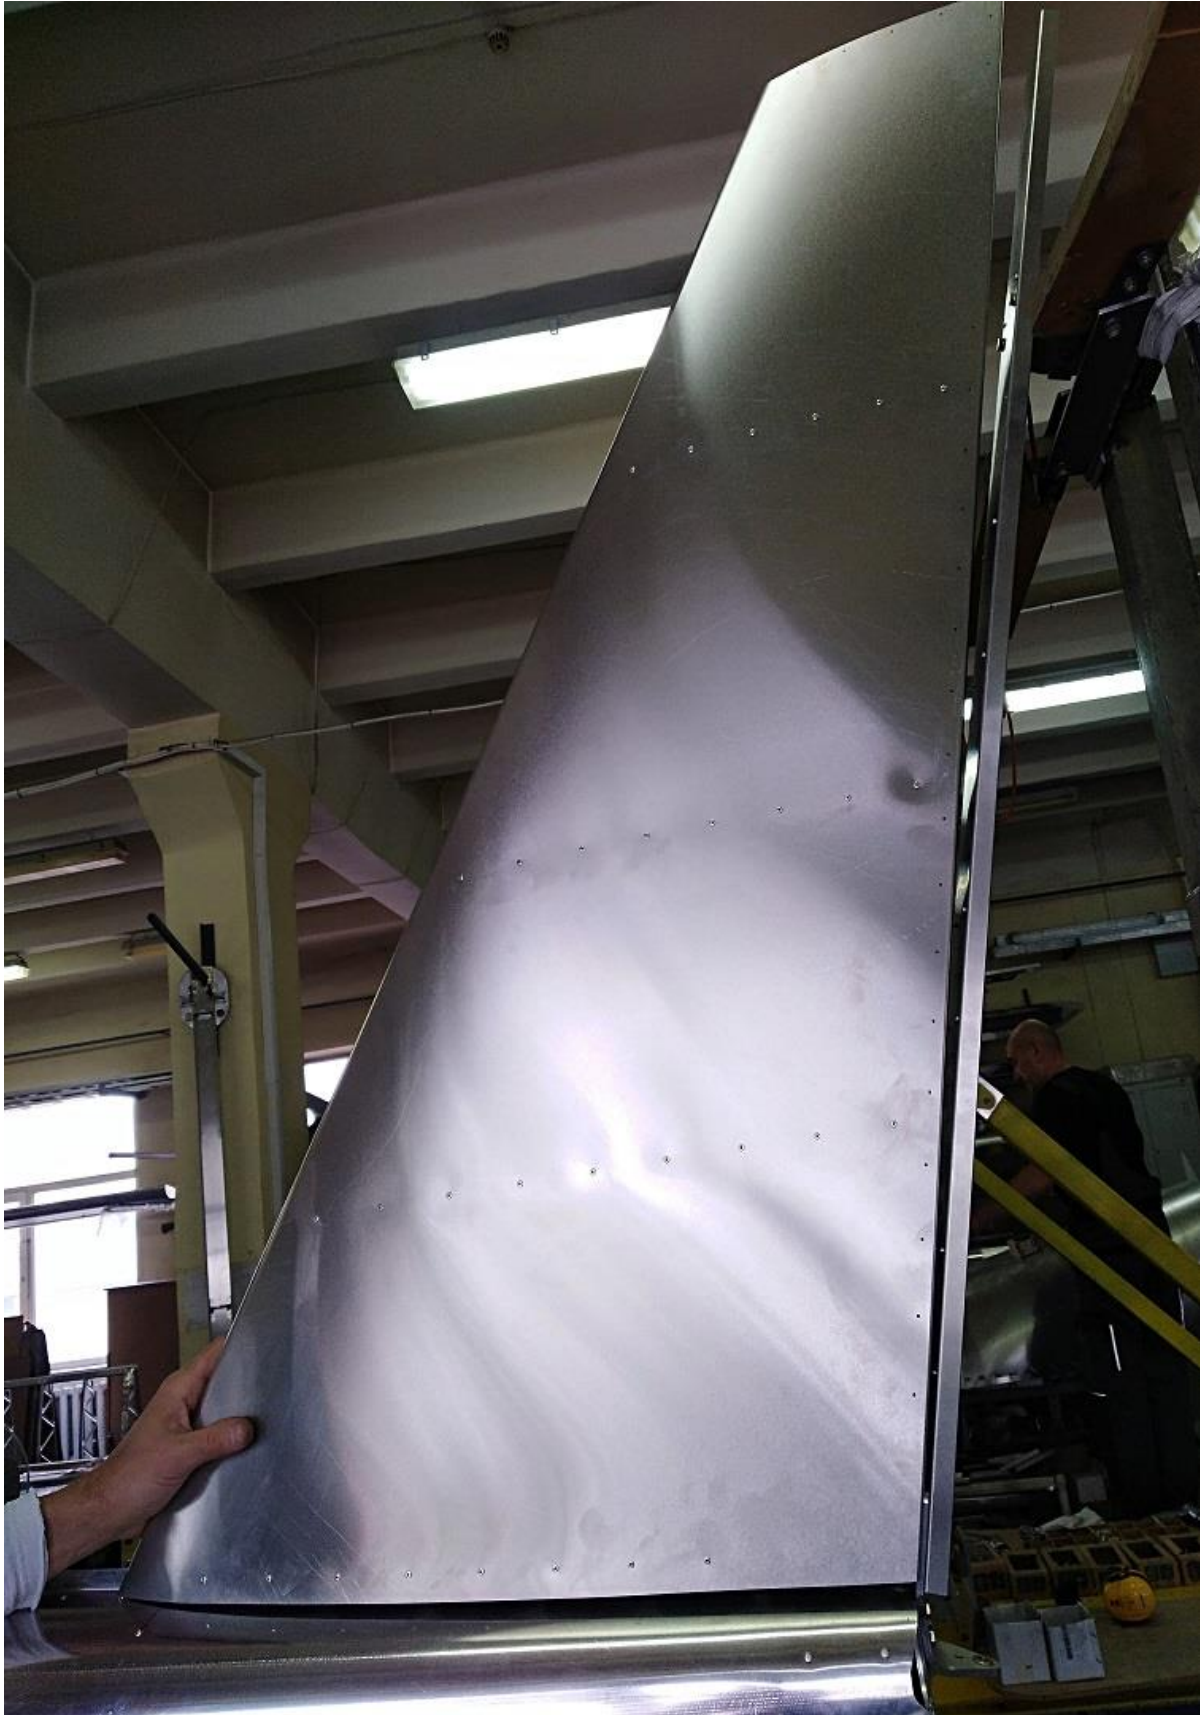
**Fig. 10.**

3.11) Remove the fin skin with ribs (Fig. 10).

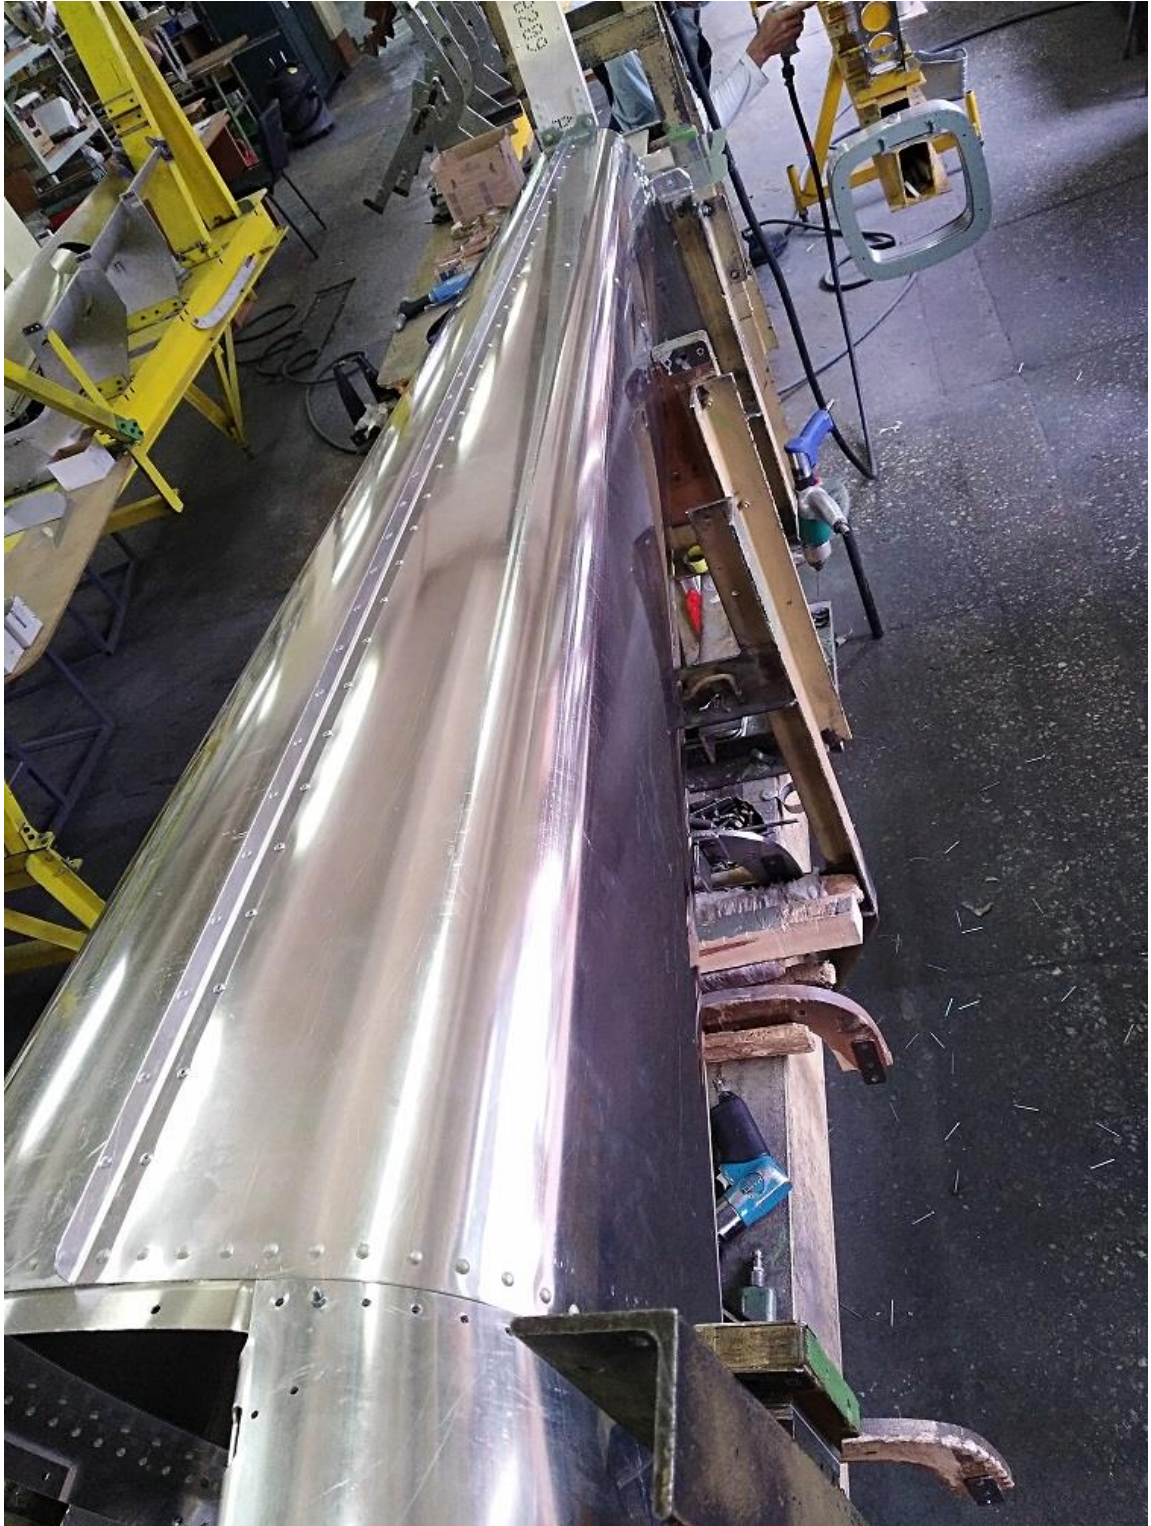
**Fig. 11.**

3.12) Drill out the rivets in the upper joint of the tail boom (Fig. 11).

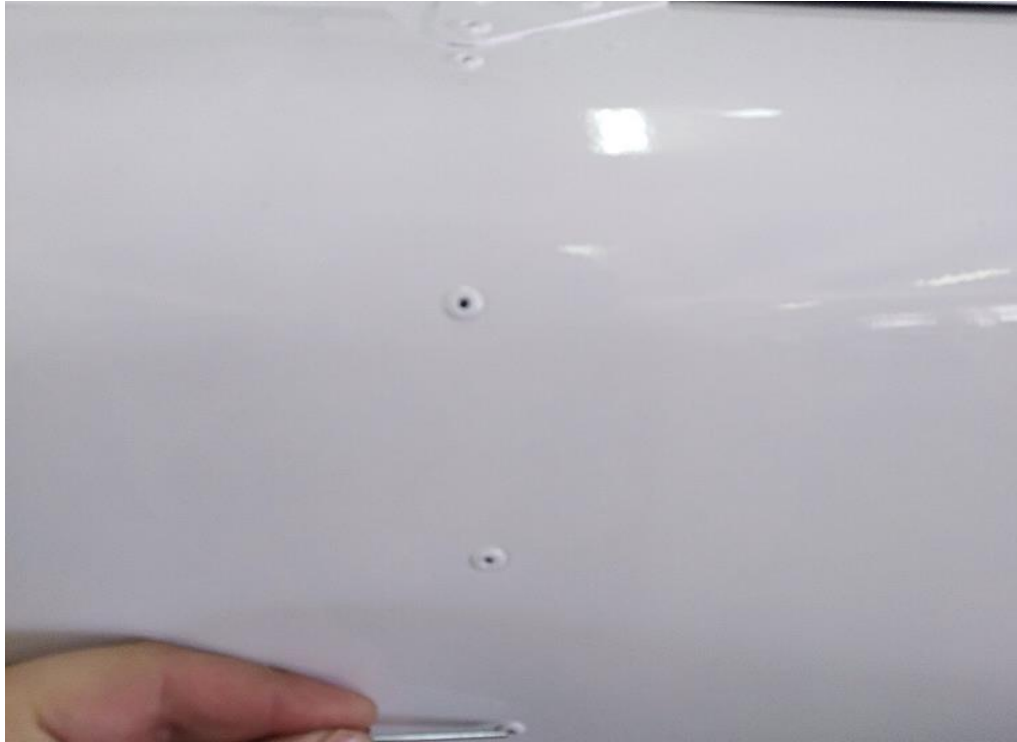
**Fig. 12.**

3.13) Drill out the rivets (except the lower ones) of the frame in the middle of the tail boom (Fig. 12).

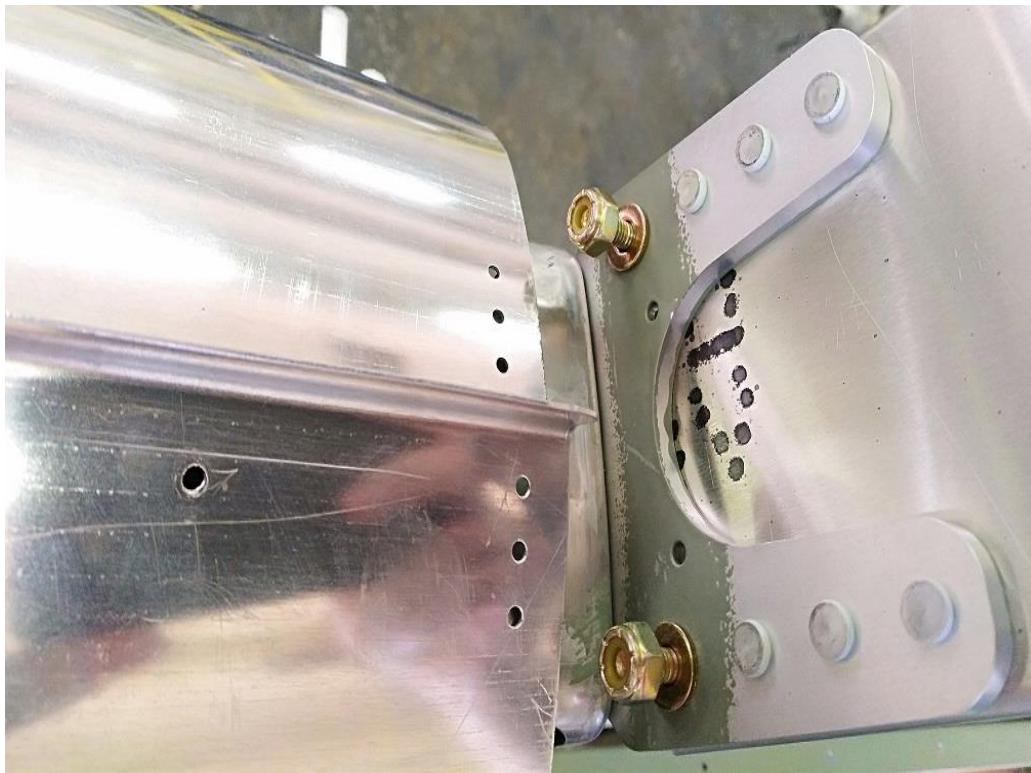
**Fig. 13.**

3.14) Remove two bolts attaching the spar (Fig. 13).

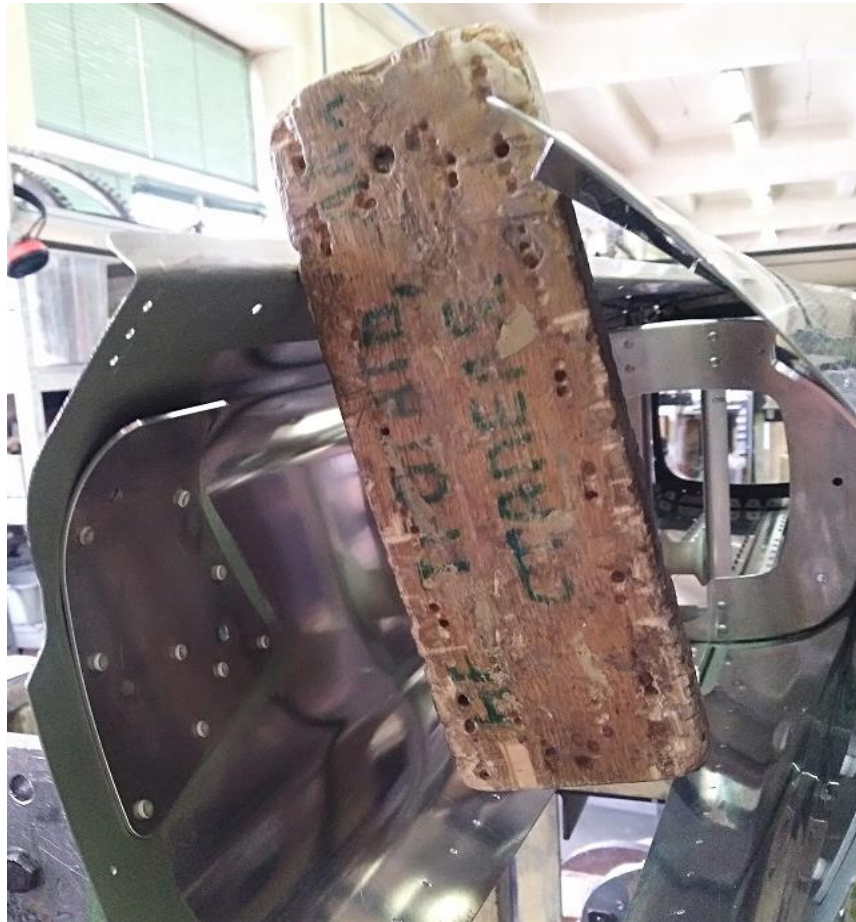
**Fig. 14.**

3.15) Separate the tail boom skins by inserting some suitable object to fix the tail boom skin in "open" position (Fig. 14).

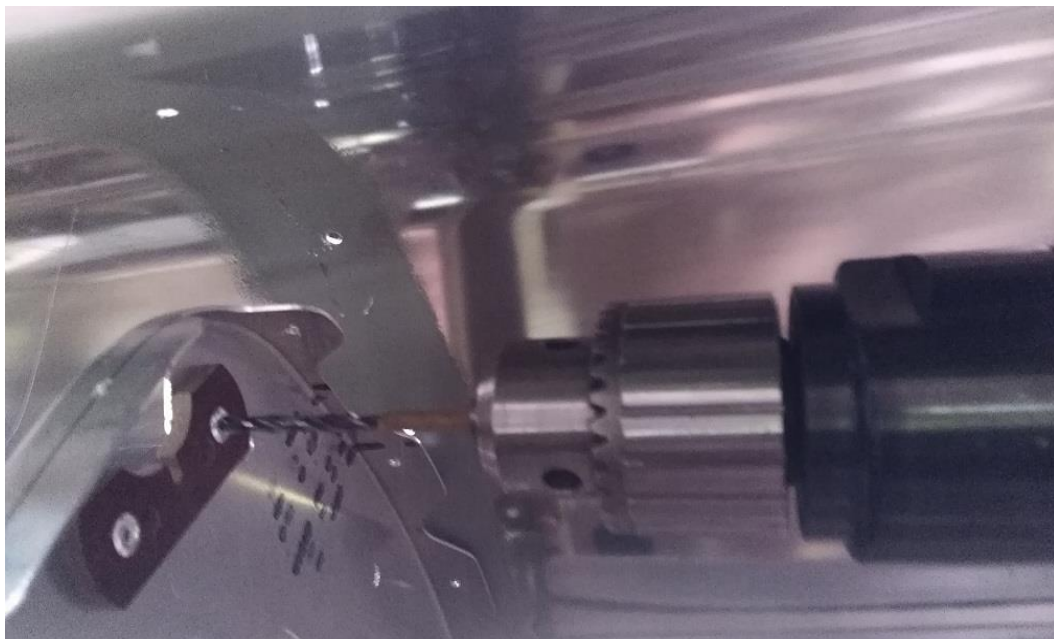
**Fig. 15.**

3.16) Drill out the rivets attaching the rudder control cable fairleads (Fig. 15).

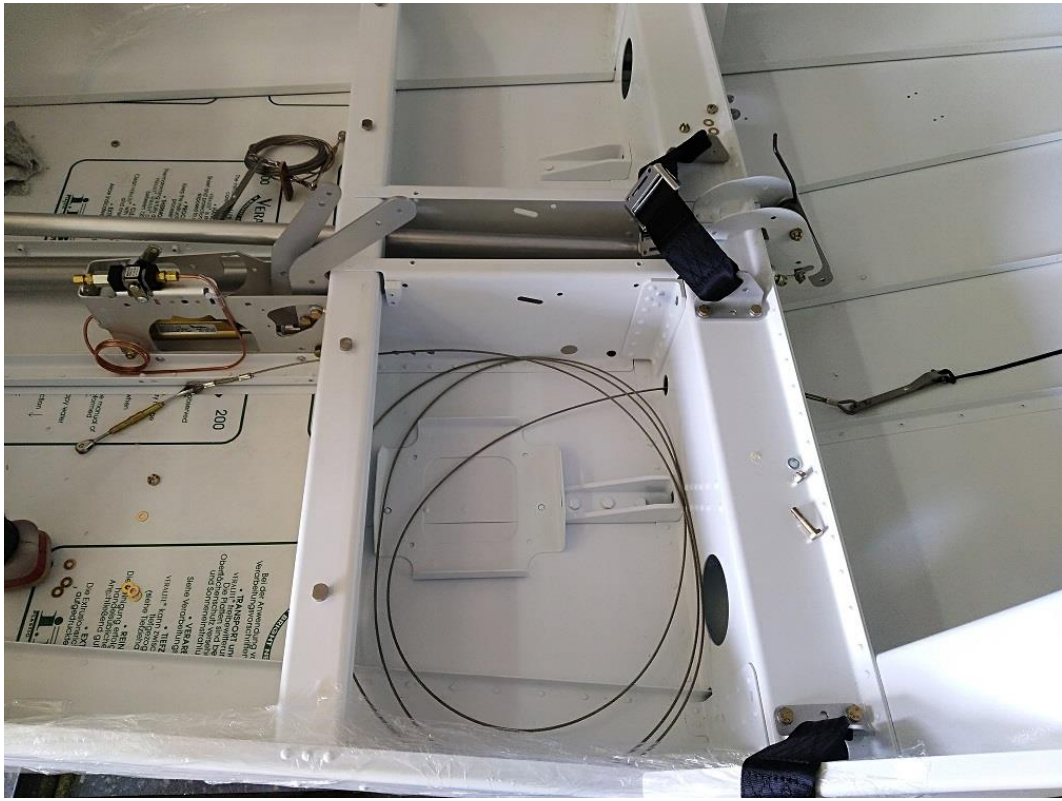
**Fig. 16.**

- 3.17) Take the cables that require replacement out of the airplane.
- 3.18) Install the new cables: insert the forward ends of the cables into the openings in the seat beam, and pass the rear ends of the cables through the openings in the landing gear beam (Fig. 16).

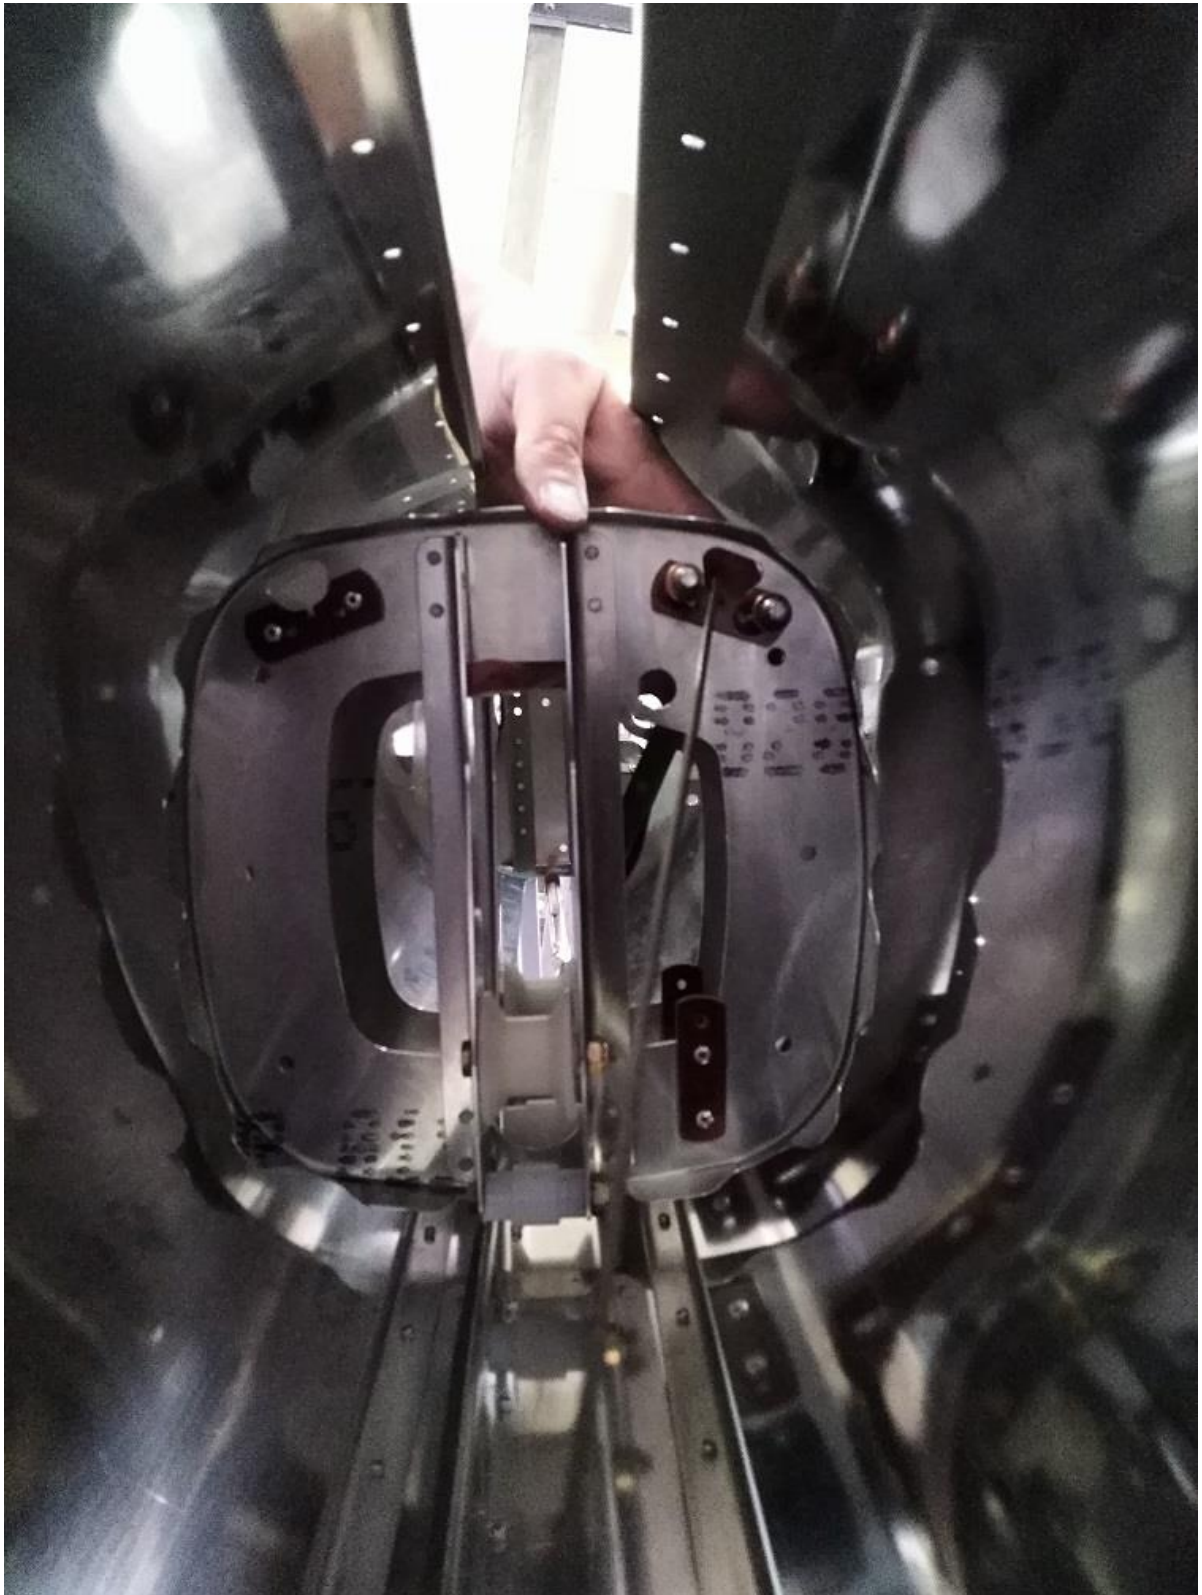
**Fig. 17.**

3.19) Pass the rear ends of the cables through the tail boom and install on CLECOs the intermediate fairleads (Fig. 17)

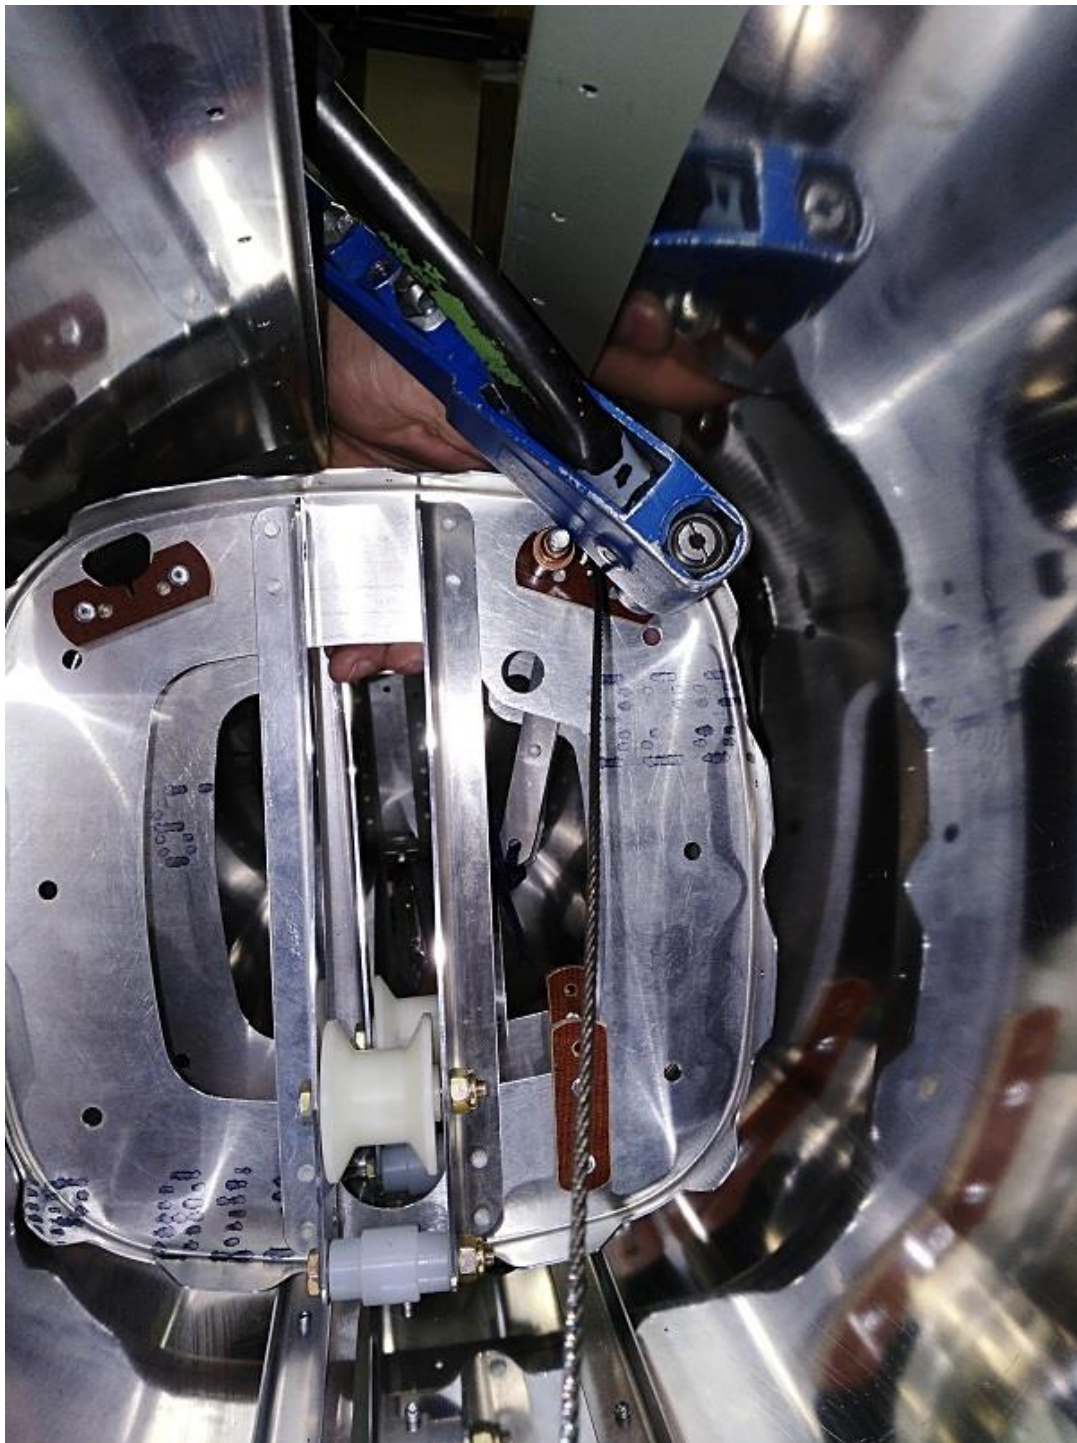
**Fig. 17.**

3.20) Rivet the intermediate fairleads (Fig. 17).
