AEROPRAKT INFORMATION BULLETIN

INSPECTION OF CARDAN RINGS AND AMMENDMENT TO AIRCRAFT MAINTENANCE MANUALS OF A-22LS AND A-22L2 AIRPLANES.

IB A-22LS-10

MANDATORY

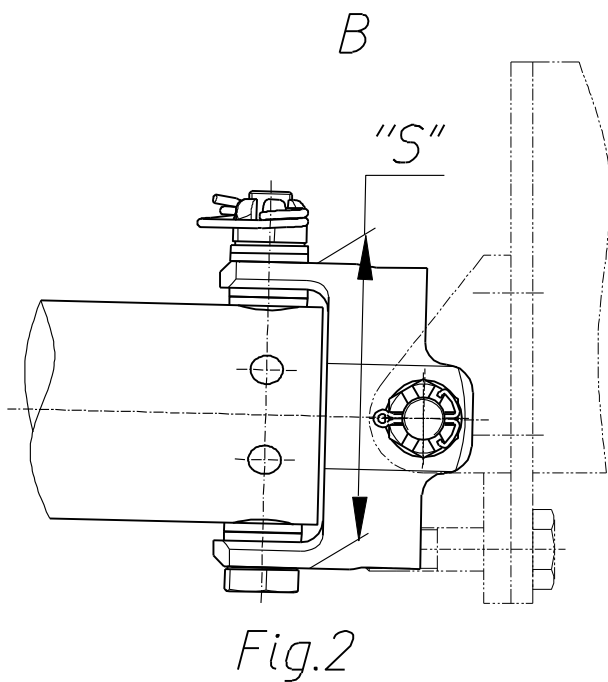
It was found out that an excessive tightening of the nut on the bolt joining the cardan ring to the flaperon shaft results in a significant deformation of the cardan ring and of the flaperon shaft end which causes cracks in the cardan ring. To avoid this excessive deformation of the joint the nut must be tightened with a torque of 2 Nm.

1. Inspect the cardan rings of the right and left flaperon for cracks (see fig. 1). Replace the cardan ring if any crack is detected.
2. If “S” dimension exceeds 55.0 mm check the nut tightening using torque wrench. If there is a gap between the flaperon shaft and cardan ring then the flaperon shaft deformation must be removed.
3. If “S” dimension is less than 55.0 mm then the flaperon shaft deformation must be removed and the cardan ring must be replaced.

Cardan rings with detected cracks must be removed from operation and delivered to the local dealer.
